Town of Ipswich Addendum to Final Report March 7, 2003

Public Safety Facilities-Additional Services

Linebrook Fire Station

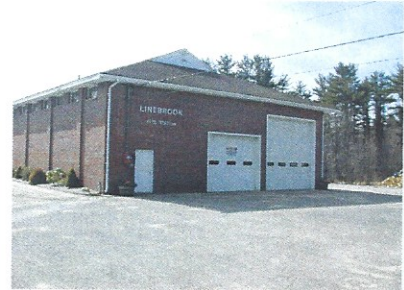
Surrounded by privately owned properties that are being used as support storage for neighboring businesses, the property lines or site circulation are not clearly defined

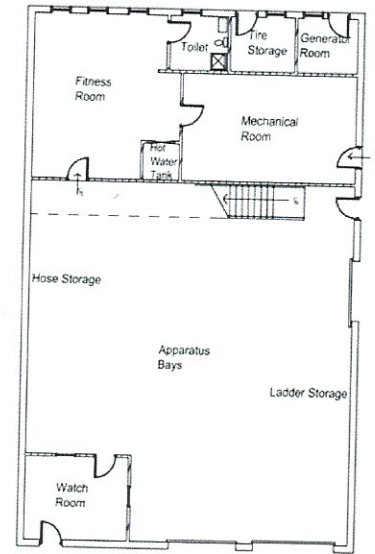
Existing First Floor Plan

The first floor of the Linebrook Station is at ground level and has two functional apparatus bays. One bay currently houses an engine waiting to be repaired. A third overhead door is located on the right side of the building. Above this door is some step cracking in the concrete masonry. One visiting the station would gain access thru the passage door at the front of the building, and enter directly into the Watch Room. The Watch Room has no visibility to the apron, and has limited visibility to the apparatus floor. Along the perimeter of the apparatus are ladder and hose storage, and a workbench. As the station is not currently housing fire fighters, the necessary support such as decontamination, laundry, turnout, and fire fighting equipment storage areas are not present.

The floor of the apparatus bays is a concrete slab on grade and has numerous shrinkage cracks. The concrete slab must be considered for repair or replacement to resolve the cracking and settling that has occurred. Wheel loads from heavy apparatus vehicles would govern redesign or repairs of the slab. To the rear of the building are an elevated fitness room, an oversized mechanical room, and a toilet room. Two rooms that are accessed from the exterior are used for tire storage and to house a non-functioning emergency generator.

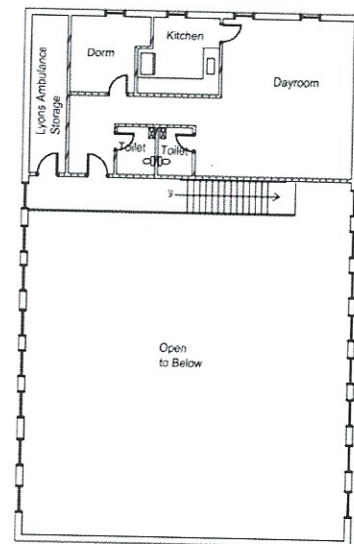
Existing Second Floor Plan

Access to the second floor is provided solely via a wood stair located at the rear of the apparatus bays. A makeshift wood railing that defines a balcony that overlooks the apparatus should be replaced with a stable and code conforming guardrail system. The remainder of the second floor provides limited living quarters and includes a large kitchen, a day room and a multi-gender toilet facility. Only one shared dormitory exists with no multi-gender shower facilities which will not support a multi-gender fire fighting force. In the corner exists a deep, narrow room used for EMS storage

The second floor framing supporting these living quarters are adequate for the code-required load of 40 pounds per square foot plus the imposed dead load. The existing 12 inch steel beam is adequate to support the code-required loads.
